NASA Contractor Report 165784

**Effect of Matrix Resin on the Impact Fracture
Characteristics of Graphite-Epoxy Laminates**

Boeing Commercial Airplane Company
Seattle, Washington

Prepared for
Langley Research Center
under Contract NAS1-15107

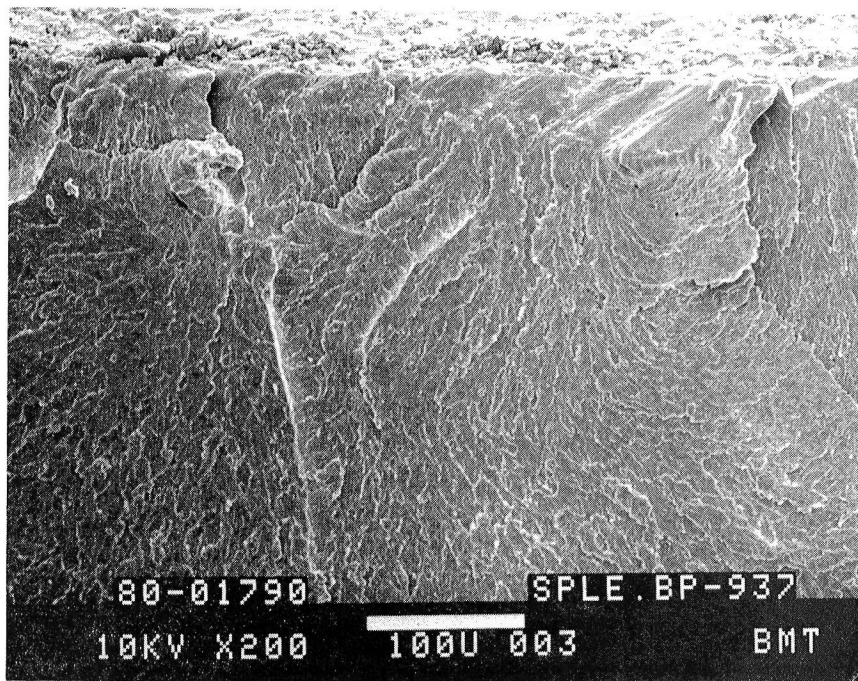
Cycom 937 (fig. 8) is a highly elastomer-modified epoxy, using a different base resin, bisphenol-A, and several different elastomer additions. Because of these additions, Cycom 937 has a much lower T_g than Narmco 5208, 121°C (250°F) versus 177°C (350°F), even though both are cured at 177°C (350°F). The elastomeric modification gives Cycom 937 a much higher strain to failure and the ability to sustain some plastic flow before ultimate rupture. This is seen in the lack of a clearly defined origin zone and the absence of transverse cleavage planes found in Narmco 5208. These features are obliterated by the ductile flow of Cycom 937 prior to failure. In addition, much

Figure 8. Neat Resin Fracture, Cycom 937 (200X)

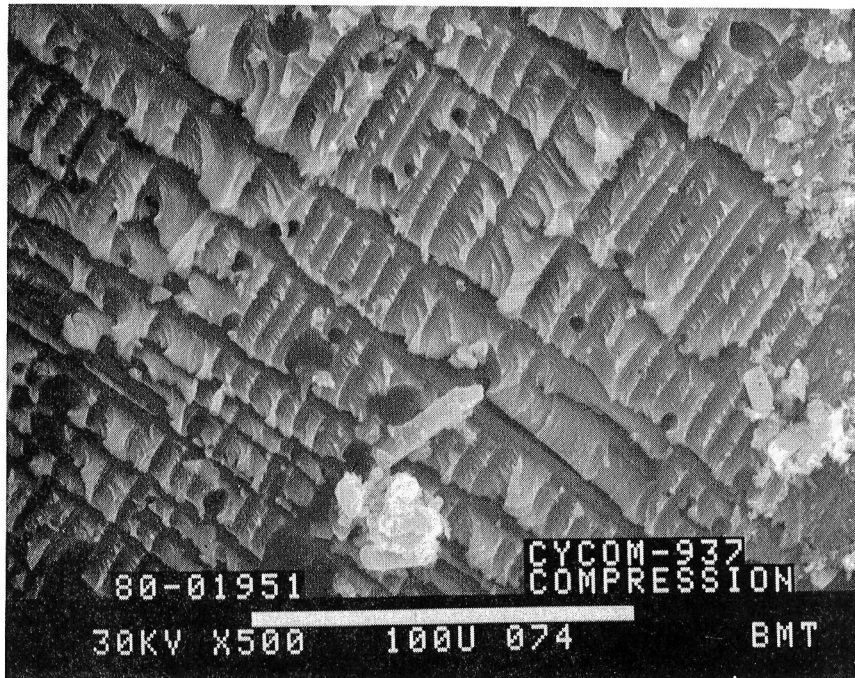
Figure 24. Compression Shear Delamination (Note Voids), Cycom 937 (350X)

Note: Voids are not crack origins.

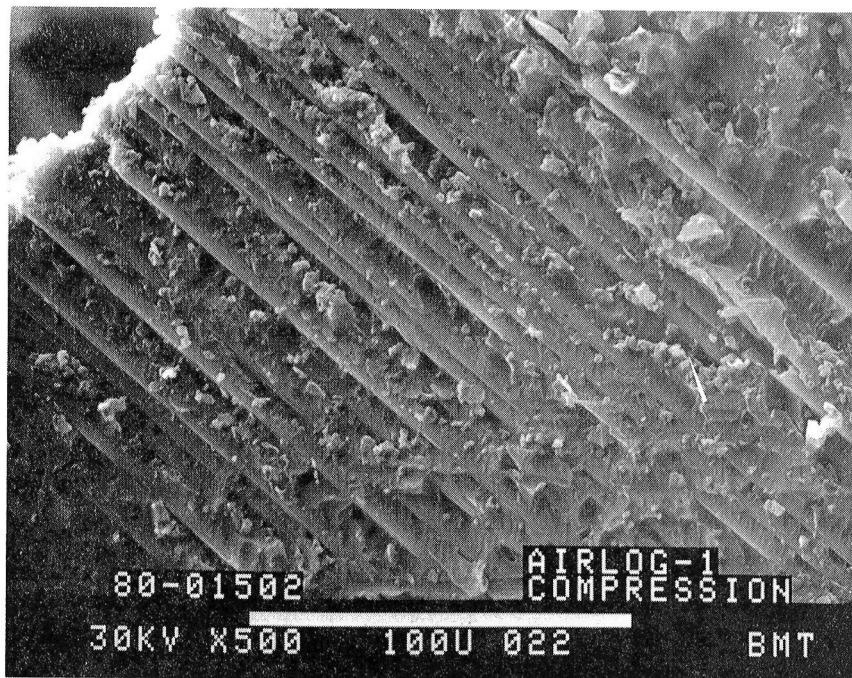
A shear failure on the compression side is shown in Figure 36. As on the tension side, massive resin plastic flow has occurred in the material between the fibers and between the plies.

Note plastic flow between fibers.

Figure 36. Compression Shear, Air Logistics 1 (500X)

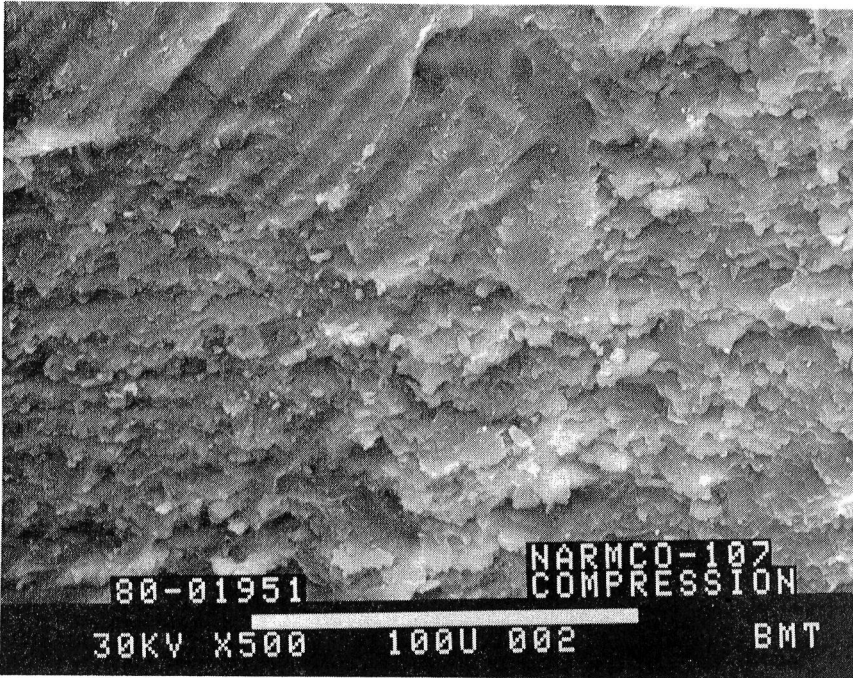
Figure 49. Compression Shear, Narmco 107 (500X)

Note: Same area as figure 47.

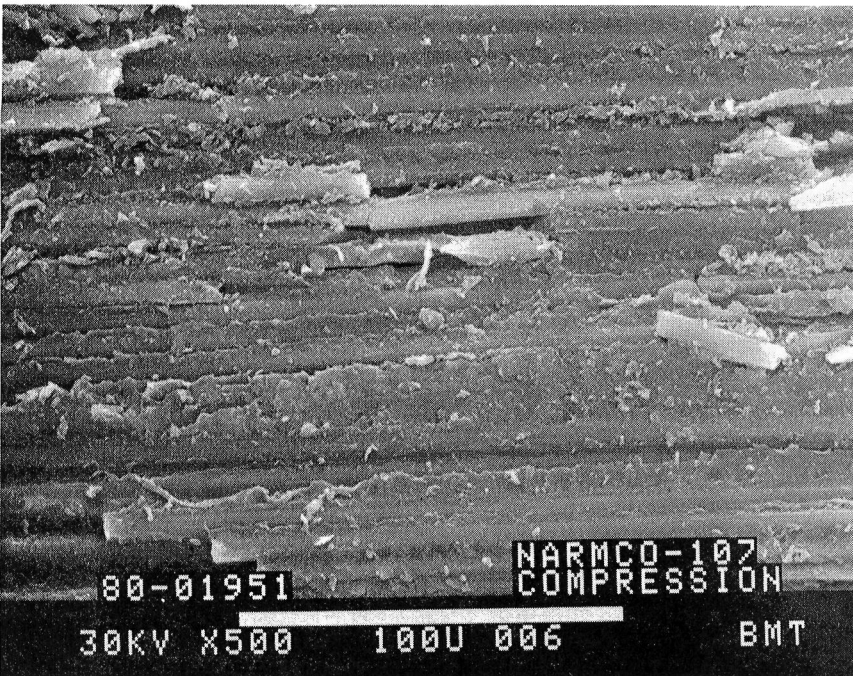
Figure 50. Transverse Fracture of 90-deg Ply, Narmco 107 (500X)

Note: Same area as figure 48.

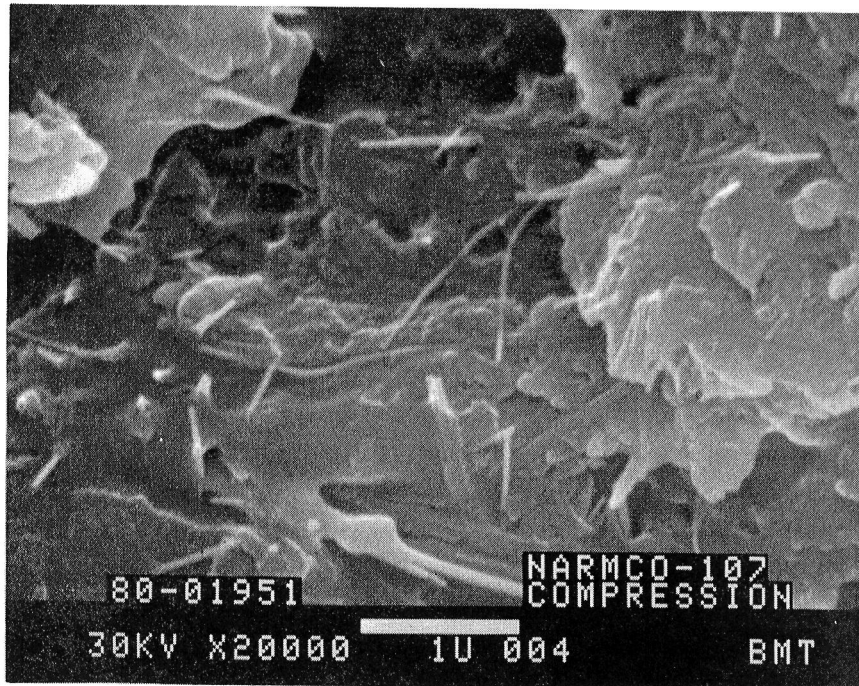
Figure 52. Hairy Skin Fracture Appearance, Shear-Loaded, Narmco 107 (5000X)

Note that hairs are part of larger resin blocks.

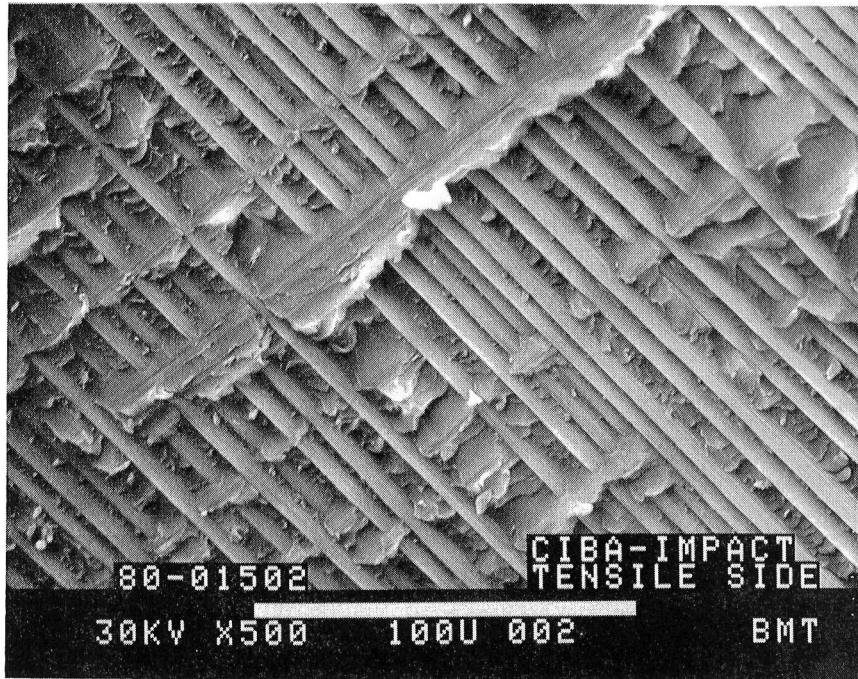
Figure 68. Typical Crossply Failure, Significant Pullout, Ciba 1M (200X)

Note rounded cleavage facets

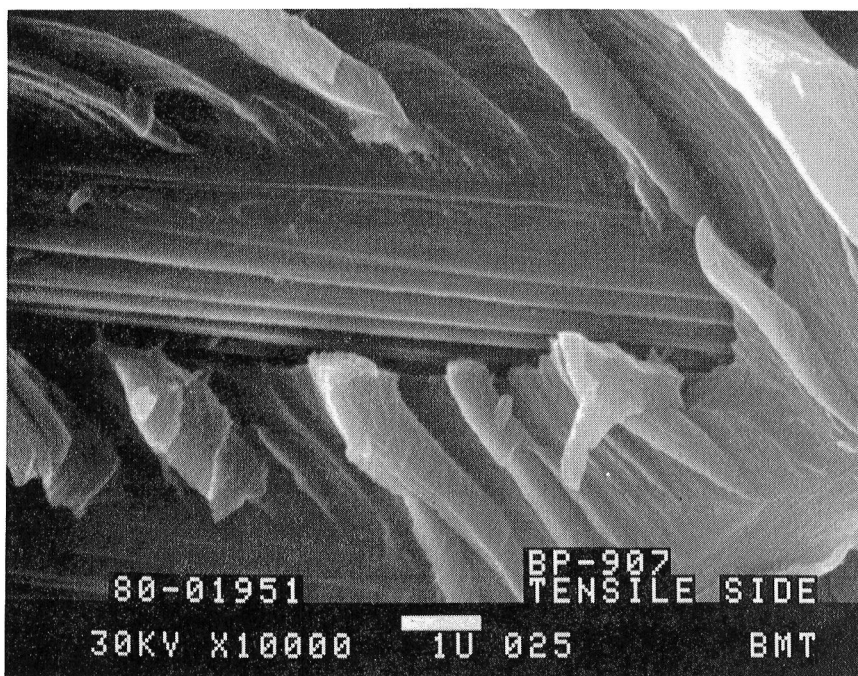
Figure 100. Microscopic Fracture Mechanism, BP-907-LR (5000X)

Note large elongated resin blocks.

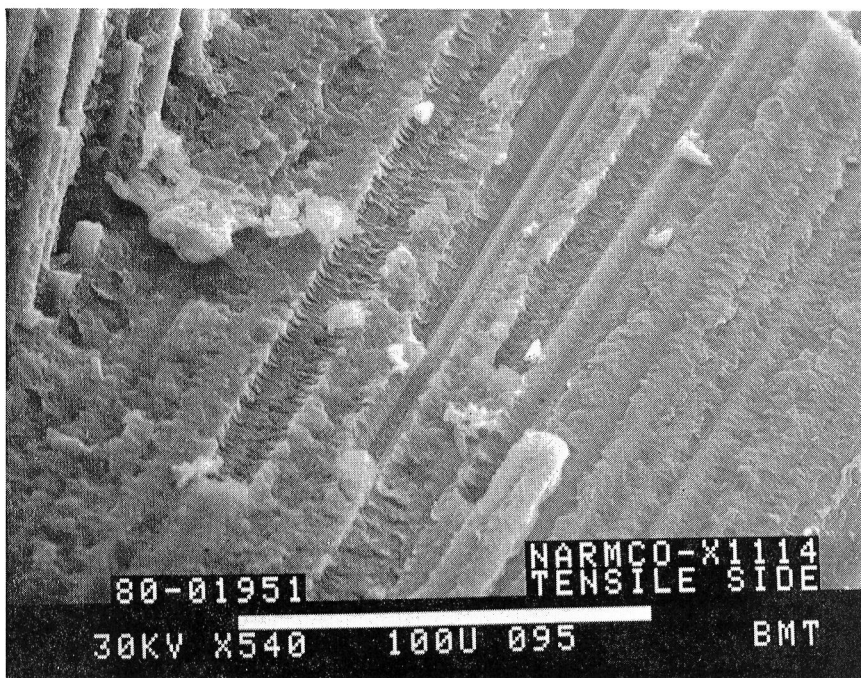
Figure 112. Tension Failure, 90-deg Ply, Narmco X1114 (540X)

Note stretched and collapsed resin.
